# Manhole Inspection Summary

## Manhole # S11AA2017MH

Insp Date: **10/19/06 8:45 AM**

**Location** Address: **5622 GREENSPRING AVE**

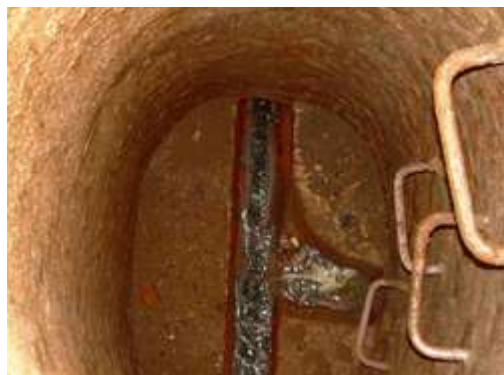
Top View

Corroded steps. Evidence of surcharge - Bench debris. Channel debris.

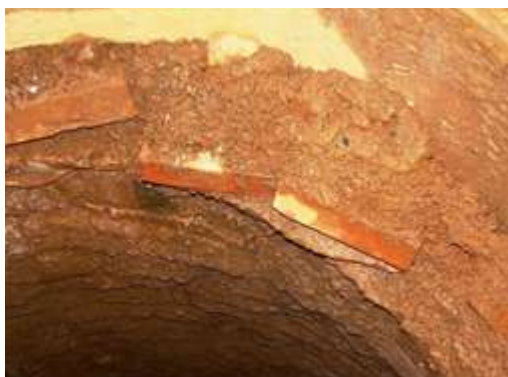
Defect

Adjustment deterioration, loose brick and infiltration. Corbel infiltration.

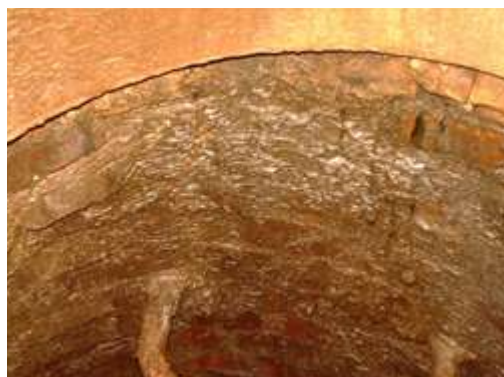
Defect

Frame leaks. Adjustment deterioration and infiltration. Corbel infiltration.

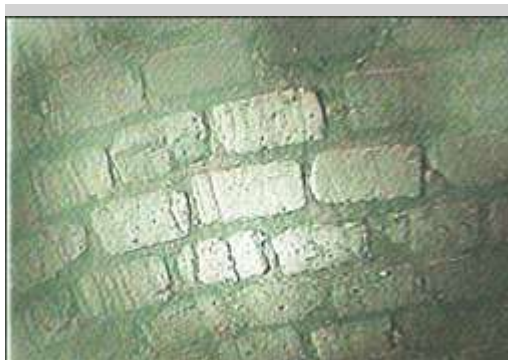
Defect

Barrel deterioration and infiltration.

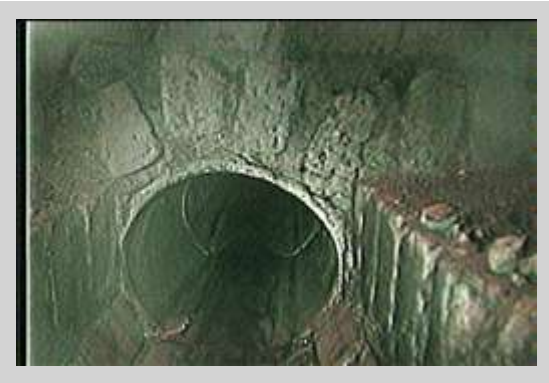
### 8 in. Circular Gravity Sewer Pipe Out @ 12 O'Clock

Infiltration: **Evidence** Pipe Seal Cond: **Cracked**

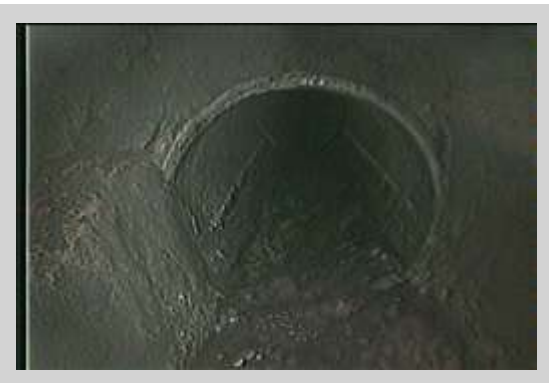
### 8 in. Circular Gravity Sewer Pipe In @ 3 O'Clock

Infiltration: **Evidence** Pipe Seal Cond: **Unknown**

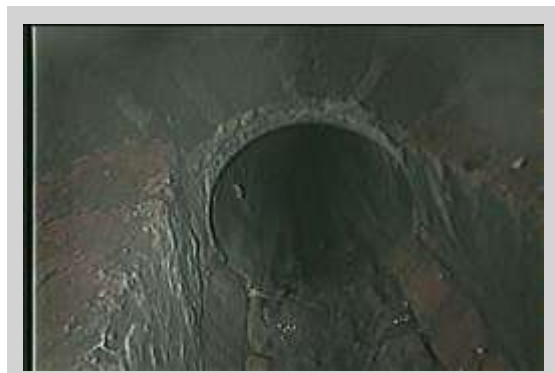
Pipe In @ 6 O'Clock

Channel deterioration.

Infiltration: **Evidence**
